MONTANA DEPARTMENT OF TRANSPORTATION STREAM MITIGATION MONITORING REPORT

*Mill Creek
Ravalli County, Montana*

*Project Constructed: 2011
Monitoring Report #4: December, 2016*

STREAM MITIGATION MONITORING REPORT #4

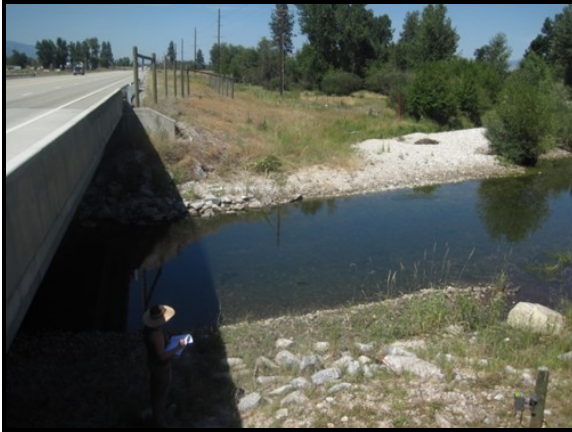
Photo Point 1.1—2013

Description: East (downstream) side of Hwy 93 Bridge. **Compass:** 45 (Northeast)

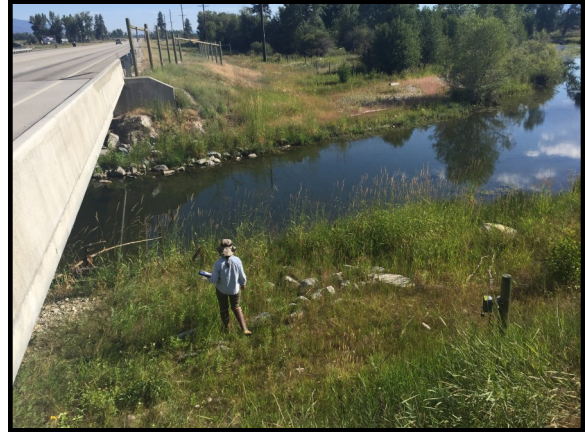
Photo Point 1.1—2016

Description: East (downstream) side of Hwy 93 Bridge. **Compass:** 45 (Northeast)

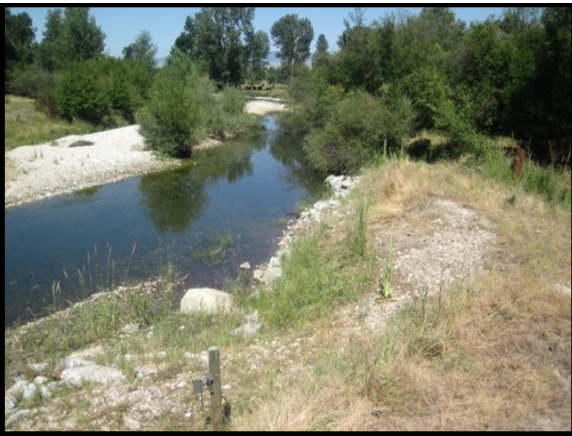
Photo Point 1.2—2013

Description: View from southeast corner of bridge looking downstream. **Compass:** 45 (Northeast)

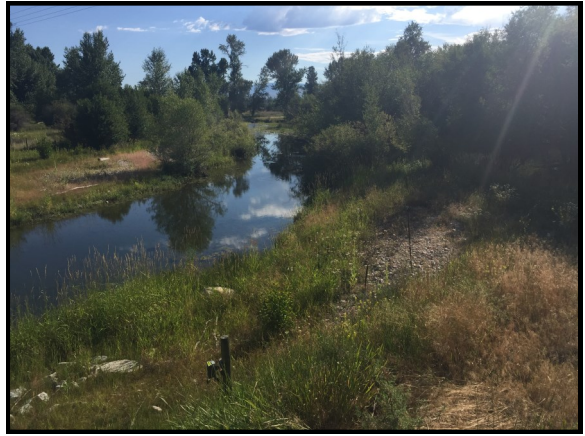
Photo Point 1.2—2016

Description: View from southeast corner of bridge looking downstream. **Compass:** 45 (Northeast)

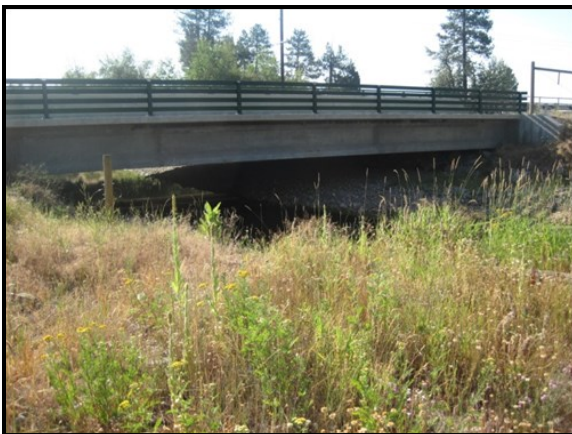
Photo Point 2.1—2013

Description: View across channel from west side of bridge. **Compass:** 113 (East-Southeast)

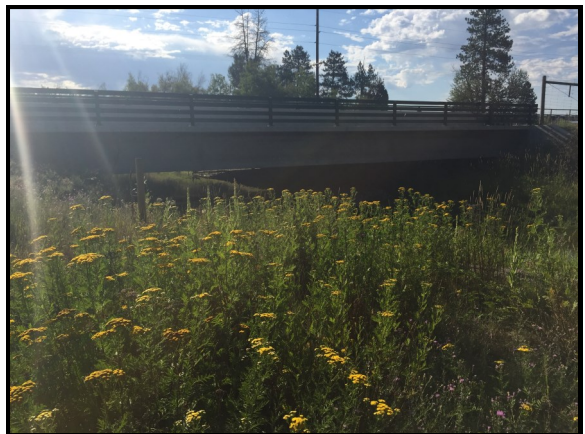
Photo Point 2.1—2016

Description: View of bridge from Photo Point 2
Compass: 113 (East-Southeast)

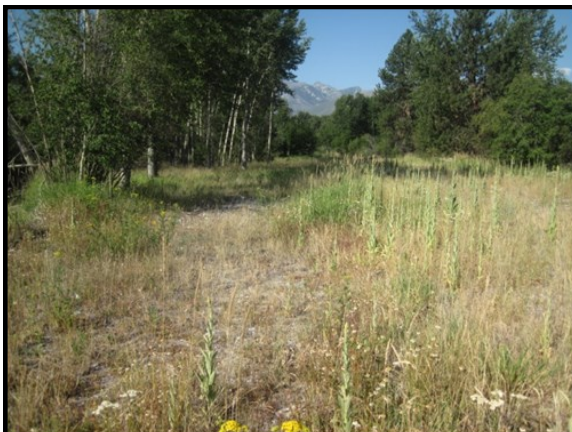
Photo Point 2.4—2013

Description: View of deactivated channel alignment
Compass: 270 (West)

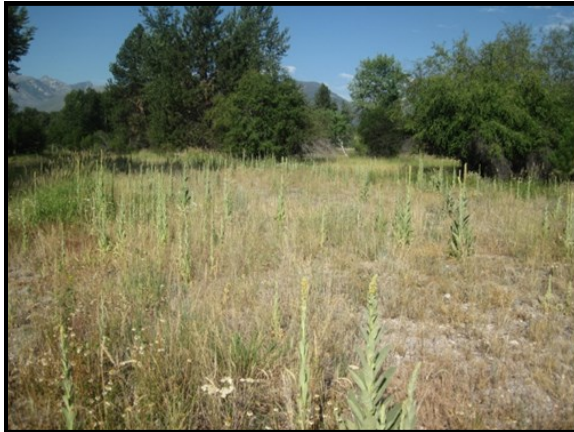
Photo Point 2.5—2013

Description: View of deactivated channel alignment.
Compass: 248 (West-Southwest)

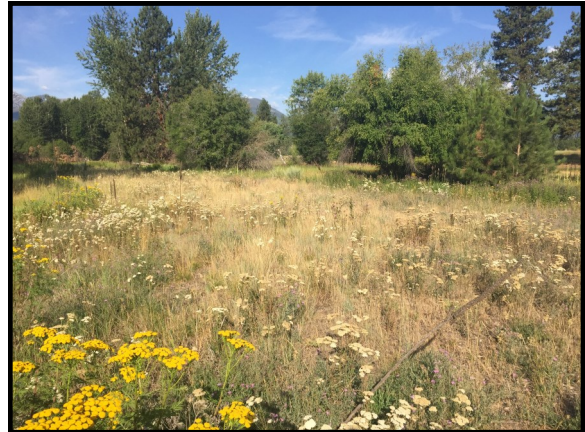
Photo Point 2.5—2016

Description: View of deactivated channel alignment.
Compass: 248 (West-Southwest)

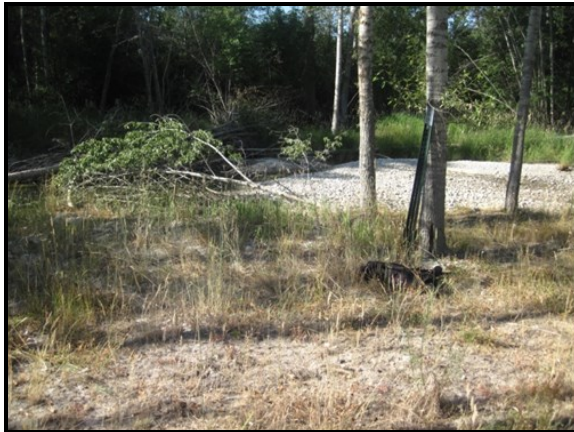
Photo Point 3.6—2013

Description: View of north bank (foreground) and woody debris in the channel. **Compass:** 248 (WSW)

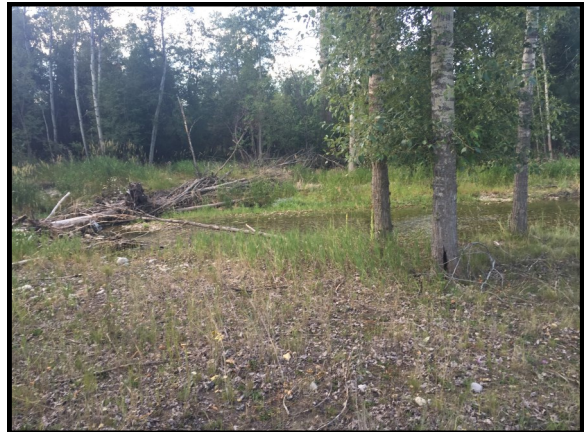
Photo Point 3.6—2016

Description: View of north bank (foreground) and woody debris in the channel. **Compass:** 248 (WSW)

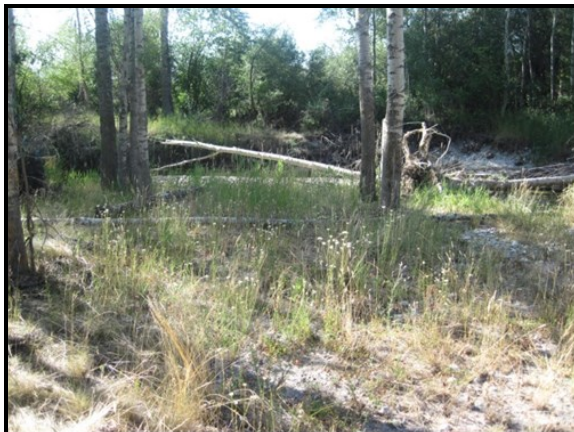
Photo Point 3.7—2013

Description: View of north bank (foreground) and woody debris in the channel. **Compass:** 180 (South)

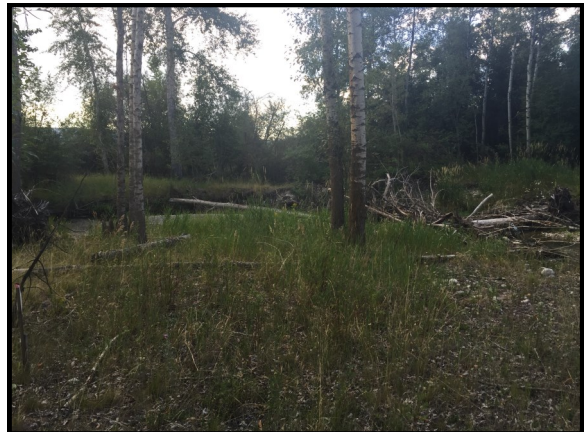
Photo Point 3.7—2016

Description: View of north bank (foreground) and woody debris in the channel. **Compass:** 180 (South)

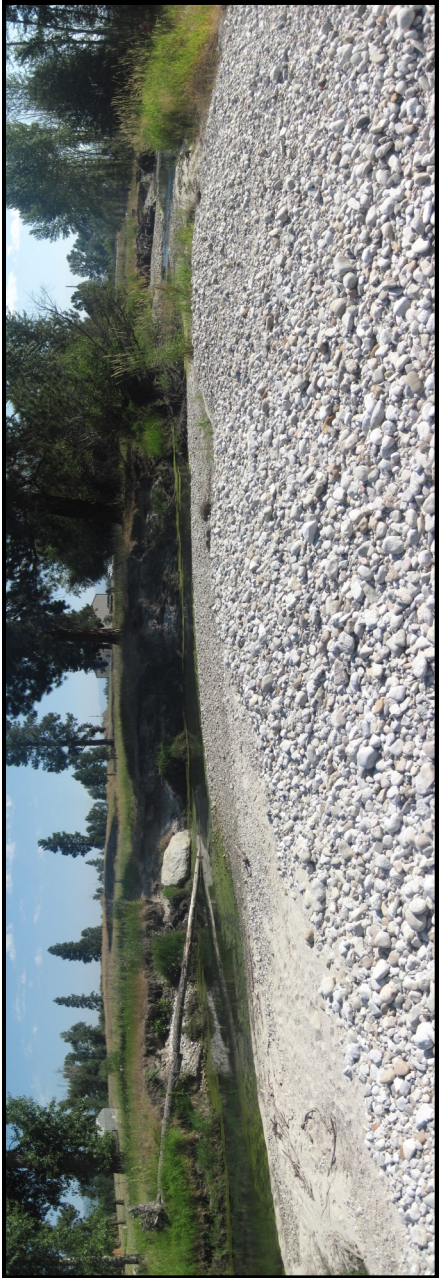
Banks EBL1 and EBL2 were originally documented as two separate eroding bank segments that combined into one long, 247-foot eroding bank in 2014 (herein referred to as EBL1-2). This bank occurs on private land upstream of the project reach, but has been documented in previous monitoring reports due to the potential of this bank affecting the project reach. The upper 150 feet of EBL1-2 appears unchanged over the past three monitoring years (see Additional Photo 1 in Appendix C); however, the lower 100 feet of the bank has continued to laterally erode northward. This 100-foot bank segment migrated approximately 2-3 feet during the past year, causing a large ponderosa tree to fall across the channel (see Additional Photo 2 and 8 in Appendix C). The fallen tree may create a debris trap during the next runoff event and result in accelerated erosion along the left bank during the next several years.

Erosion of the north bank (EBL1-2) immediately upstream of the project reach has advanced northward each year since the inaugural monitoring event in 2013. This bank occurs upstream of the relocated channel segment, and has been continuously observed due to its influence on the reach immediately downstream. This bank migrated an additional 2-3 feet during the past year, causing a large ponderosa pine tree to fall into the river. While recruitment of woody debris is considered a positive effect on the channel due to its ability to help develop pool habitats, this tree is large enough to trap other woody material and result in more accelerated channel migration in its vicinity. Channel migration near this downed tree should be monitored to document whether unintended erosion occurs as a result of its presence.

Additional Photo 2
Description: Eroding Bank EBL2- 2013 (panoramic)

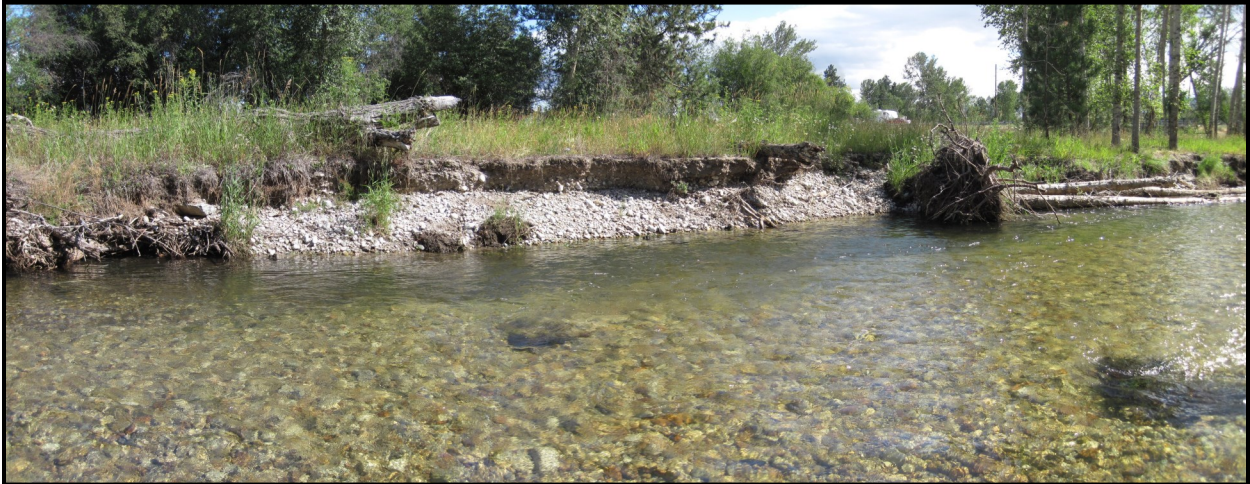
Erosion at EBL3 is occurring at the head of the former channel alignment (now backfilled with gravel, cobble, and soil), and extends downstream approximately 90 feet beyond the root ball of a fallen tree. In 2014, erosion was noted along the toe of the

bank, causing it to retreat. The vegetation community consists of short-awn meadow foxtail, white and red clover, Kentucky bluegrass, common tansy, and ox-eye daisy, all of which are species that are less capable of withstanding erosive forces. Erosion along this bank did not appear to advance in length or retreat further in 2015 or 2016 (see Additional Photo 3 and 4 in Appendix C). Based on the combination of erosion factors, severity of erosion along EBL3 is considered low and no corrective actions are necessary along this bank.

Description: Upper section of Eroding Streambank EBL3 in 2014

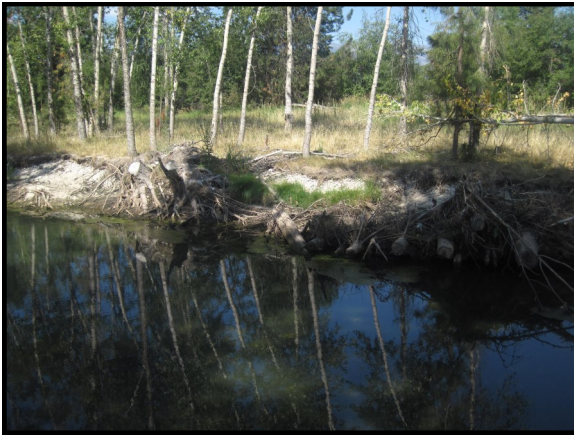
Lateral erosion at bank EBL4 appears to have continued since 2015, as evidenced by the adjacent root balls detaching from the bank (see Additional Photo 5 in Appendix C). The bank has retreated approximately 4-5 feet since 2013, although the eroding bank length of 64 feet has not increased. Bank instability at this location was potentially caused by removal of the trees for use in log revetment construction, or from natural channel adjustments following construction. The dominant vegetation along the bank includes reed canary grass and smooth brome, the former of which offers dense roots capable of withstanding erosion more effectively than most species. Erosion severity along this bank is considered low to moderate and does not jeopardize any infrastructure elements or the newly installed bridge downstream. As a result of the erosion occurring likely as a result of natural channel adjustments, no corrective actions are warranted at this location.

Description: Eroding streambank EBL4 in 2013.

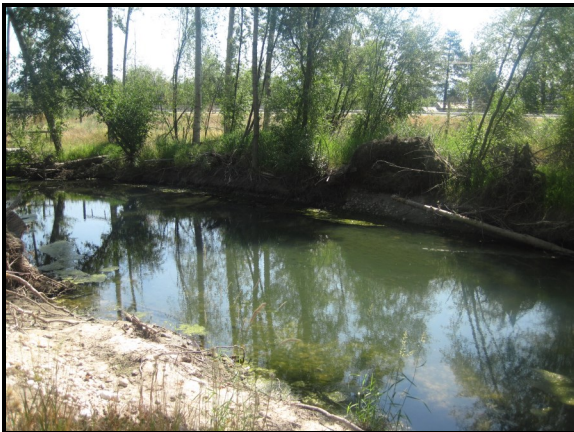
Eroding bank EBR1 occurs directly across the channel from EBL4. Previous monitoring efforts documented fallen trees both into the channel and away from the channel along this bank, although it appears no additional erosion has occurred along the bank since 2014 (See Additional Photo 6 in Appendix C). The vegetation community along this bank consists of cottonwood, speckled alder, smooth brome, and bog birch, most of which are generally promote bank stability due to their ability to generate dense root masses. Bank erosion severity along this 58-foot segment is considered low, and the bank has not continued to erode since 2014. These factors combine to indicate no corrective actions are warranted along this bank.

Description: Eroding streambank EBR1 in 2013.

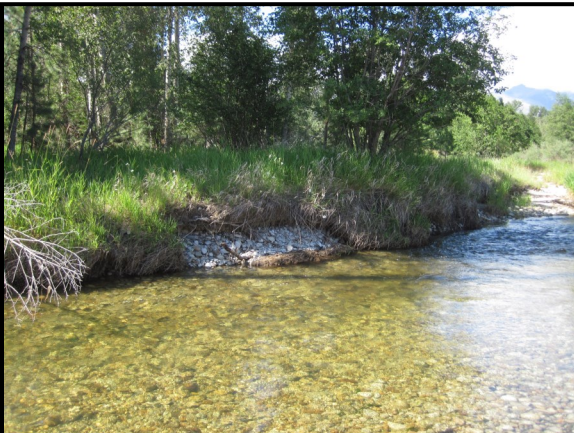
Erosion at EBR2 was noted along 65 feet of the channel across from the head of the deactivated stream channel. Erosion at this location is due to channel adjustments and scour along the outside of a meander. No additional erosion was noted over the past two years along this bank (see Additional Photo 7 in Appendix C). The vegetation community is dominated by reed canary grass with a speckled alder and bog birch overstory. Each of these species are generally capable of withstanding erosive forces. These factors contribute to an overall low erosion severity rating and no corrective actions are warranted along this bank.

Description: Eroding streambank EBR2 in 2014.
